NASA
Technical
Paper
3222

Hot Fire Test Results of Subscale Tubular Combustion Chambers

John M. Kazaroff,
Robert S. Jankovsky,
and Albert J. Pavli

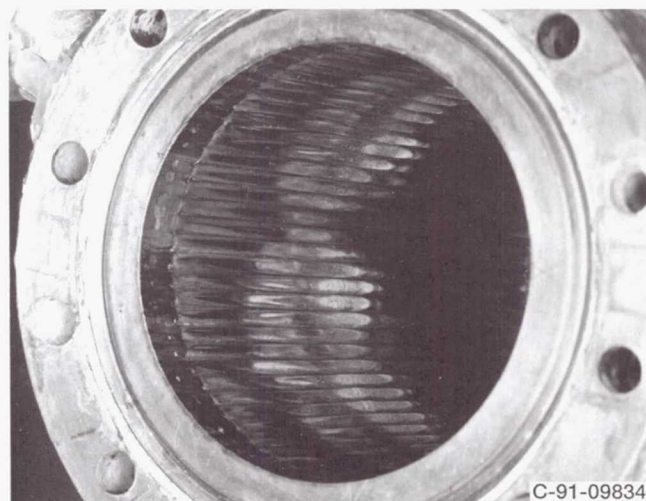
Figure 7 shows the inside surface of the second chamber after the 637 firing cycles. Surface roughness measurements were made on the tube centerlines at the throat prior to testing and, again, after 637 cycles. The roughness before testing was measured as 32 $\mu\text{in.}$, or less. After testing, the average surface roughness in the throat region was 300 $\mu\text{in.}$, with a range from 152 to 534 $\mu\text{in.}$ This roughening, termed "blanching," is caused by cyclically repeated oxidation and reduction reactions between the combustion gases and the copper wall. A thorough examination of this process is reported in reference 7, which includes data of surface roughness as a function of the hot-gas-side wall temperature. For the wall roughness measured on the second chamber (300 $\mu\text{in.}$), reference 7 predicts a temperature of 830 °C (1525 °F) for the hot-gas-side wall temperature. Although the crown temperature at throat plane at the start of testing was estimated to be 570 °C (1060 °F), the surface deterioration caused by blanching raised the temperature to an estimated 830 °C (1525 °F) before the testing was suspended. Continued cyclic testing would have lead to a chamber failure. Furthermore, the failure would not be a conventional fatigue failure caused by

Figure 7.—Second tube chamber after 637 firing cycles.

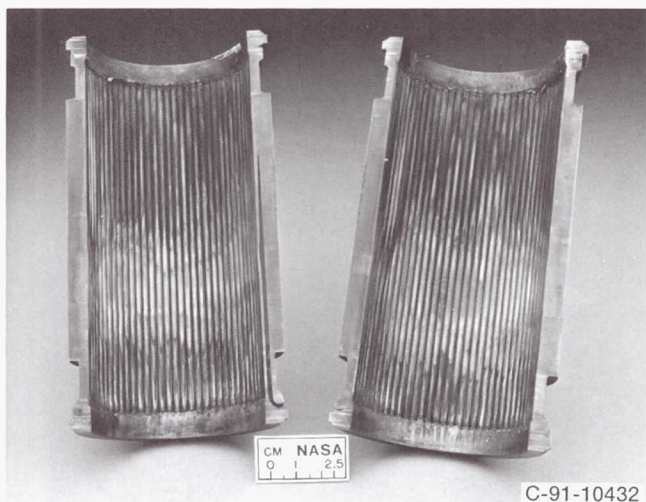
Figure 8.—Third chamber after firing showing failure and throat area roughness.

To reduce the cost of running many cycles, a set of more severe test conditions was selected for the third chamber. These conditions were a combustion-chamber pressure of 4137 kN/m^2 (600 psia), a mixture ratio of 6.0, and a coolant flow of 0.807 kg/sec (1.78 lb/sec). Figure 6 shows that the coolant flow of 0.807 kg/sec (1.78 lb/sec) was expected to produce a crown temperature of 671°C (1240°F). The expected life at this temperature for the 72 milled-channel chamber configuration would be 118 cycles (ref. 5). The actual life obtained from the third chamber before it failed was 256 cycles. Figure 8 shows the inside of failed chamber number three. The distress in the throat location can be easily seen. Surface roughness measurements made on the tube centerlines in the throat region ranged from 178 to $573 \mu\text{in.}$, with the average at $360 \mu\text{in.}$ Referring to reference 7, this roughness corresponds to a wall temperature of 849.2°C (1560°F).

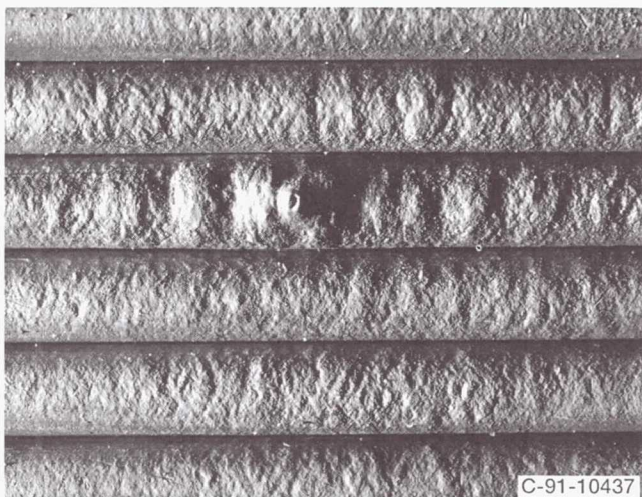
Figure 9.—Failure site.

Figure 9 shows the failure site with lighting located close to the surface to provide good contrast of the surface texture. The failure appears as a protrusion in the surface shaped like a volcano, clearly indicating that the failure was a pressure rupture. Figure 10, taken just downstream of the location shown in the previous figure, shows the downstream end of the blanched zone of the throat. Visible on the smoother and cooler surfaces are a series of round globules, indicating the attachment of molten copper from the throat region. This molten copper is also apparent on tubes that are adjacent to the failure, indicating that even the unfailed tubes had surface melting and that the surface temperature was higher than the roughness correlation of reference 7 would predict; that is, 1083°C (1981°F) instead of 849.2°C (1560°F).

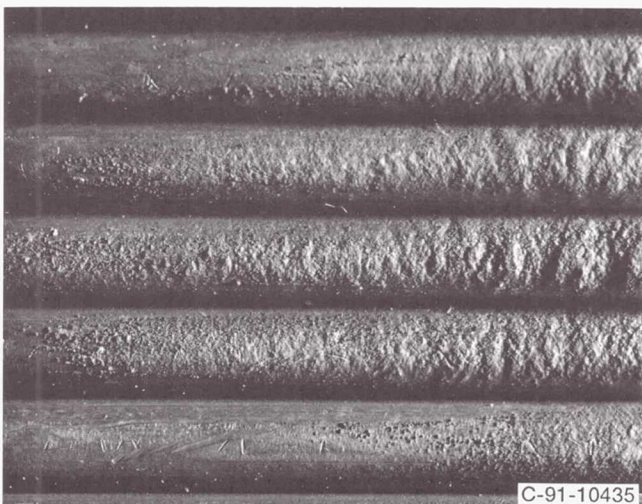
Figure 10.—Surface downstream of failure site.

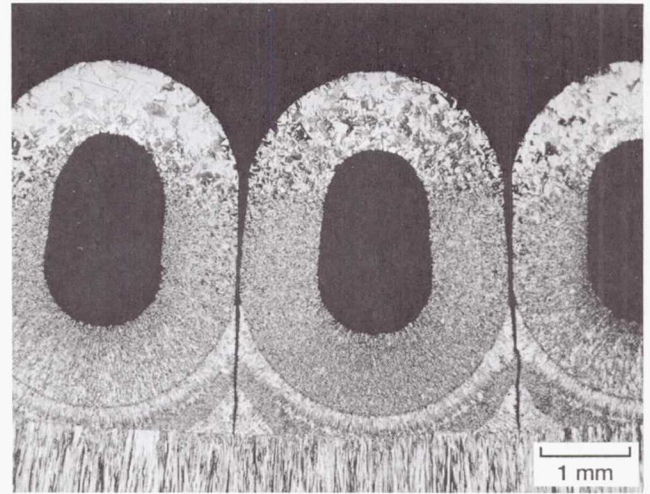
Figure 13.—Cross section 0.84 cm downstream of the throat.

Figure 13 is a photograph of the specimen taken at a location 0.84 cm (0.33 in.) downstream of the throat. The temperature at this location is low enough to result in less distress of the cooling tubes. The thinning at the top of the tubes and the increase of coolant-passage height is less severe, indicating less tensile yielding due to the coolant pressure forces. The grain growth is also less severe as the fine grain on the bottom continues farther up the sides of the tubes; the grain size at the top of the tubes is somewhat smaller than the grains of the previous specimen. Also, this figure illustrates the forming of the expansion gap in the same manner as the previous two figures. It is obvious that the feature of structural compliance performed as expected. The expansion joint between the tubes shows no crack propagation beyond the initial dimension.

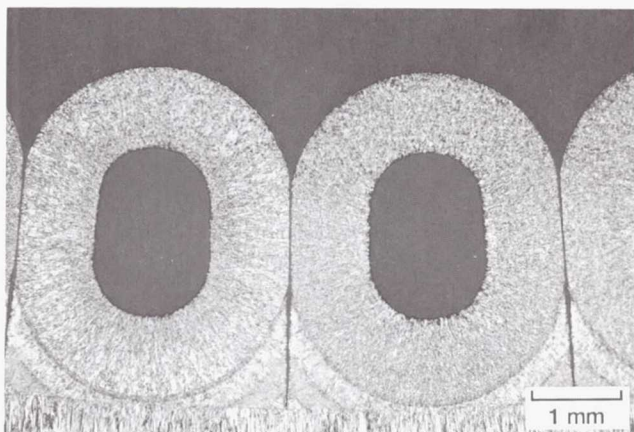
The next specimen was obtained farther downstream at a location 1.27 cm (0.5 in.) downstream from the throat. Figure 14 is a photograph of this specimen, and it shows no distress at all. The grain structure is uniform from top to bottom of the tube indicating no annealing and grain growth. Furthermore, there is no evidence of yielding or coolant-passage distortion. The expansion joints appear as fabricated with no evidence of plastic deformation on the first cycle and with the bond line between tubes as originally fabricated.

Figure 14.—Cross section 1.27 cm downstream of the throat.

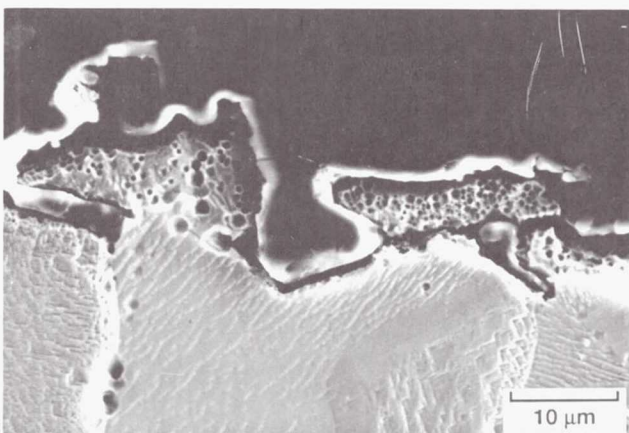
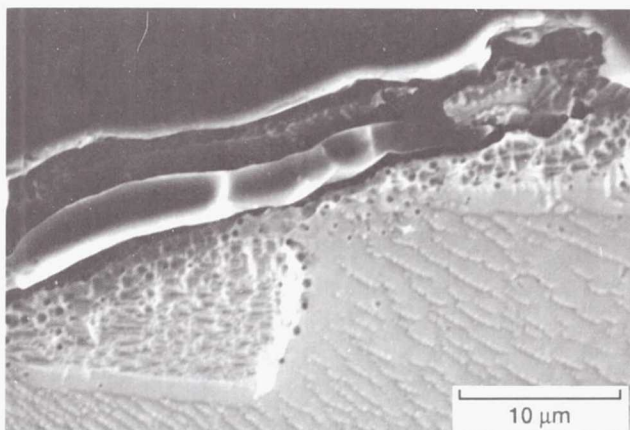
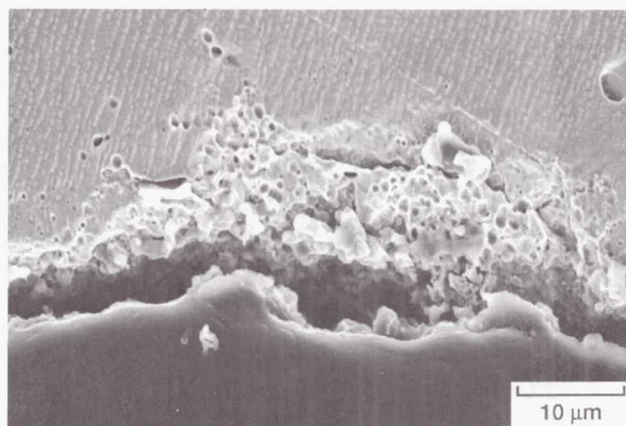
In addition to metallography, several of the chamber specimens were analyzed using the scanning electron microscope (SEM). The SEM photographs (figs. 15 to 17) showed that the hot-gas-side surfaces had considerable porosity and some recast copper. The porosity and recast copper indicate that a temperature above 1083 °C (1981 °F), the melting point of copper, was obtained. These findings are similar to those

Figure 15.—SEM showing porosity and recast copper downstream of failure site.

Figure 16.—SEM of area downstream of failure site.

Figure 17.—SEM showing porosity and recast copper in tube away from its failure site.

reported in reference 7. This is further evidence that severe blanching of the tubes occurred.

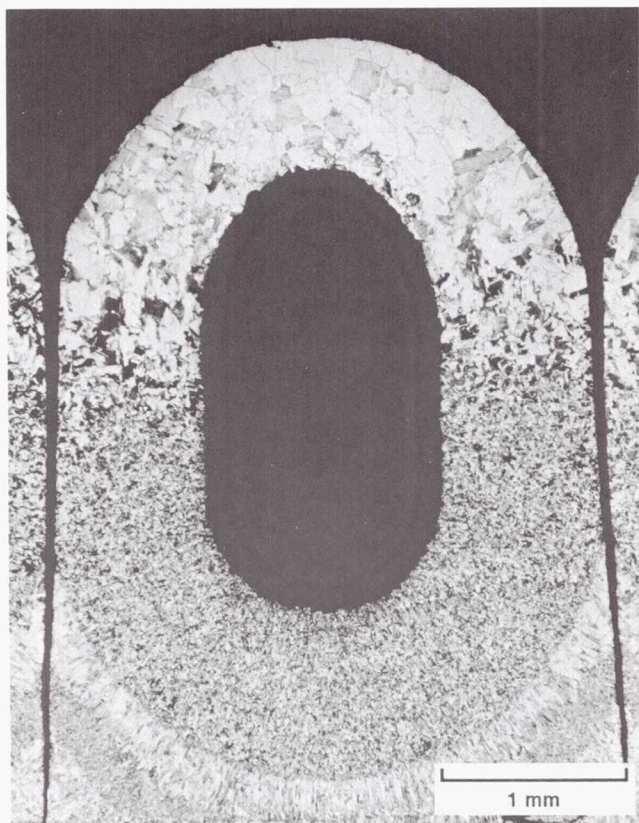
Figure 19.—Cross-section of fired tube sample taken from 0.42 cm downstream of the throat showing grain structure.

the wall material of a fired chamber (also photographed at 25×) is shown in figure 19. The grain sizes are equivalent, indicating that they had been exposed to the same temperature. However, the tube sample of figure 19 was taken from a location of 0.42 cm (0.16 in.) downstream of the throat area.

Figure 20 shows the grain size resulting from exposure to 538.1 °C (1000 °F). Grains of this size are also seen in figure 19, which shows an area just below the crevice region. This indicates that the temperature in the crevice region was slightly higher than 538.1 °C (1000 °F). This accounts for a crown to crevice difference of just under 204.4 °C (400 °F), which agrees reasonably well with the analytical prediction of 171.4 °C (340 °F) for this difference.
